AmeriSpec Inspection Services
Inspection Report
(604) 430 – 0343

This home is a condominium in a multiple story wood frame building.

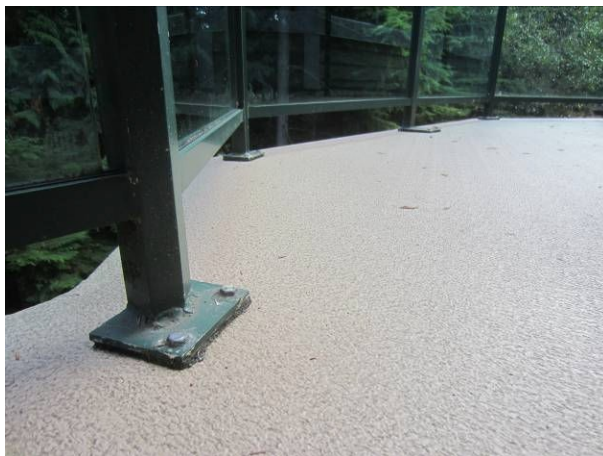
N.
Serviceable. No GFI provided to outlet. See #408.
Waterproof membrane over wood structure.
N.
Metal & Glass. Recommend sealing around railing penetrations into balcony to prevent possible moisture ingress. Recommend reviewing with strata representatives or Management Company.
Limited access to underside for inspection.

Recommend sealing around balcony railing penetrations.

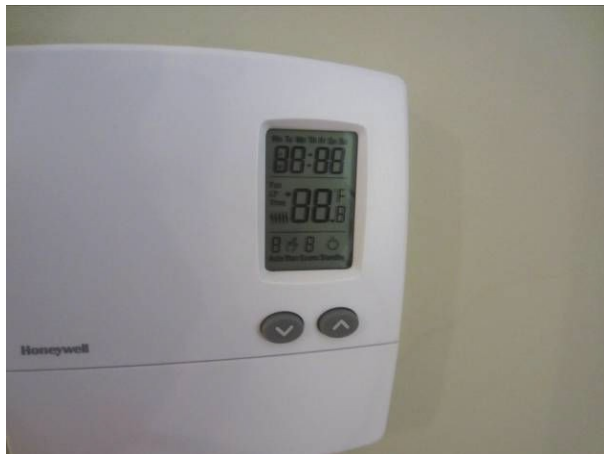
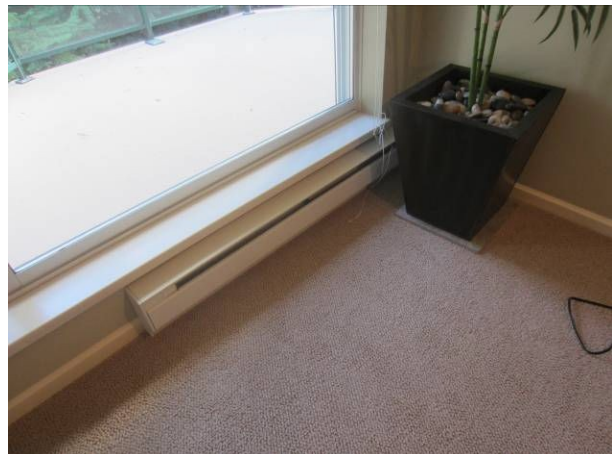
- 401 Heating:** Electric baseboard.
- 403 Thermostats: Thermostat in living room was not working adequately at time of inspection. Error signs were showing on display. Indicating problem with thermostat or electric baseboard. Recommend a review by a qualified contractor. Repair or replace as required.

Error signs on thermostat display. Electric baseboard is not working adequately.

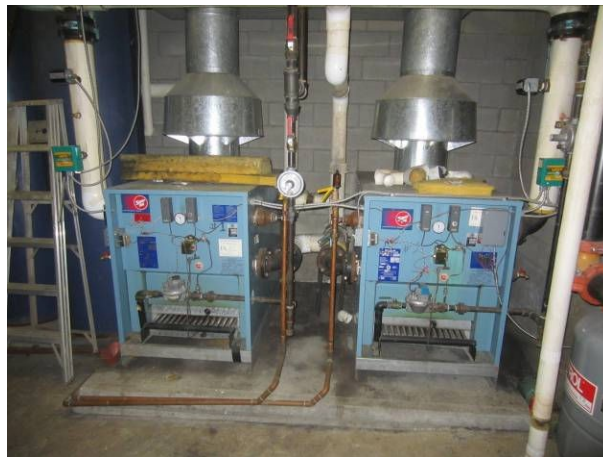
Hot water is provided by a central boiler system, located in underground parking level. Hot water noted at all fixtures inside unit. Boilers are original to complex and are in serviceable condition. Due to the complex and inaccessible nature of these systems, client is advised to consult a qualified heating contractor for verification of performance. Recommend reviewing with strata representatives or Management Company.

Hot water boilers.

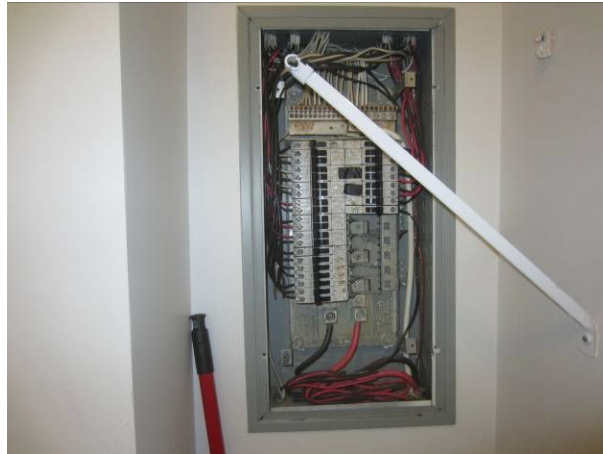
Overload protection is provided by breakers. Main disconnect breaker not present inside unit. Main service conductor part of panel not accessed due to high voltage present. Some minor corrosion noted at neutral cross bar. Bubbling paint noted to wall at top left corner of electrical box. No moisture was detected at time of inspection. Suggest contacting vendor for further information.

Electrical panel.

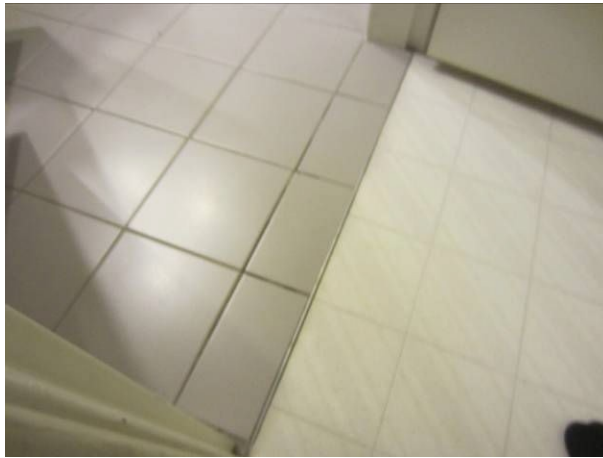
701 Floor:	Tile cracked grout noted in areas. Repair or replace as required.
------------	-------------------------------------------------------------------

Cracked grout noted to bathroom floor tiles.

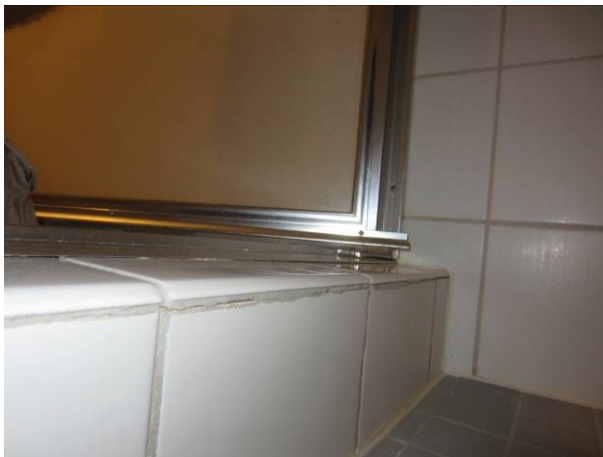
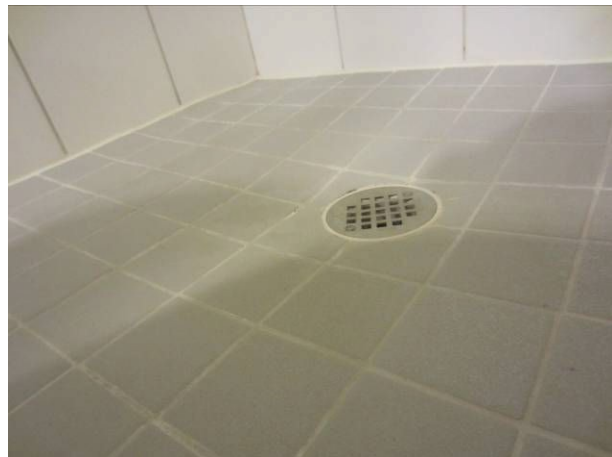
Cracked grout noted inside shower stall.

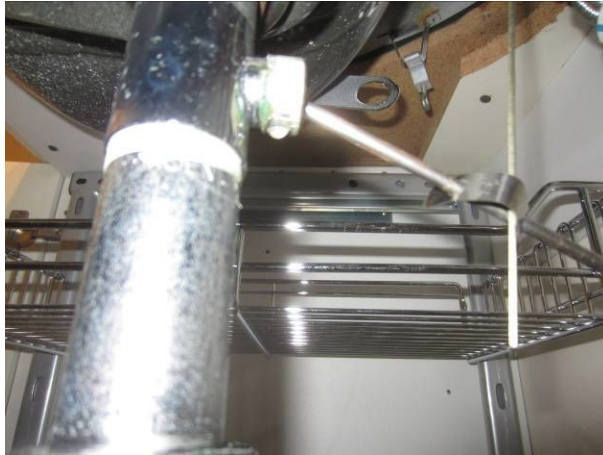
- 713 Shower Door: Glass.
- 714 Shower Head: Serviceable.
- 715 Sink: Serviceable.
- 716 Sink Faucet: Serviceable.
- 717 Drain/Supply Pipes: Small drip leak noted from stopper arm. Repair or replace as required.

Drip leak noted at stopper mechanism under sink.
