AmeriSpec Inspection Services
Inspection Report
(604) 430 – 0343

This home is a condominium in a multiple story wood frame building.

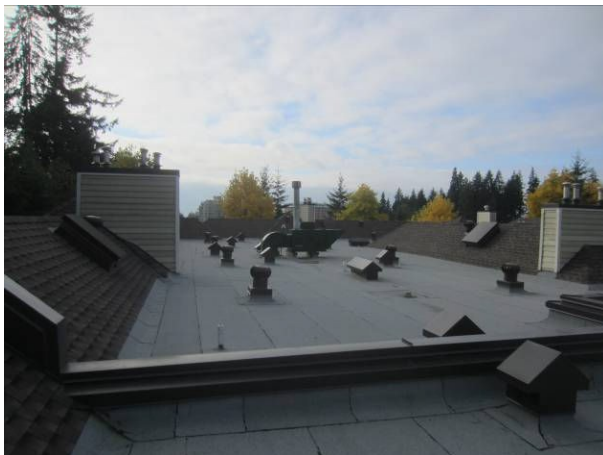
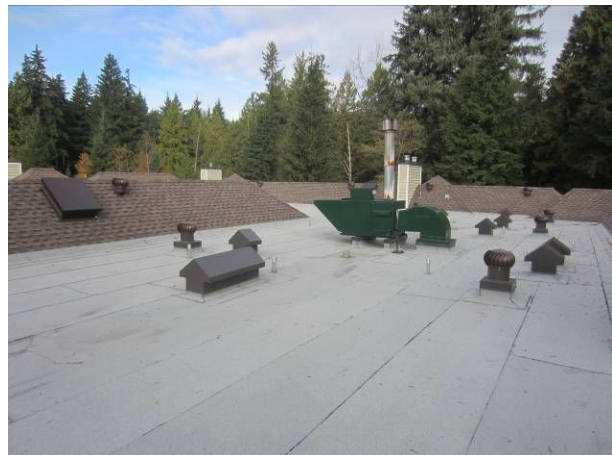
- 126 Comments: Review is in relation to building #3690 of this complex only. Recommend reviewing with strata representatives or Management Company.
